Save the Queen: Preservation + Adaptive Reuse in Hawai'i

Submitted towards the fulfillment of the requirements for the Doctor of
Architecture degree

School of Architecture
University of Hawai'i at Mānoa

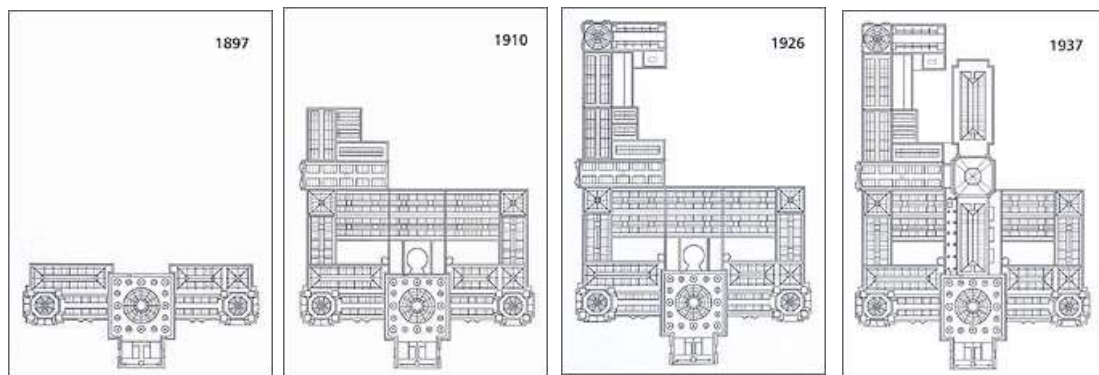
Figure 12 Development of Tate Britain Source:
http://www2.tate.org.uk/archivejourneys/historyhtml/bld_brit_extensions.htm

that made it a curious location for an art gallery. It was originally a prison, Millbank Penitentiary to be exact. It was the largest prison in Europe in its time and was the main point of departure for the prisoners being sent to the penal colony of Australia.¹⁹ The site was chosen as explained on the Tate Gallery website, “Although decaying and derelict (with the added gloomy association of the notorious and disease-ridden prison), the potential of the site with its river views and space to build was recognized, and in 1892 Millbank was officially chosen as the site for the new 'National Gallery of British Art'.”²⁰ The latest alteration was the result of the Tate Modern being opened that caused the change in the art works that would be displayed. In 2001 the Tate Britain altered five existing galleries and added a new entrance. They also converted storage areas into a research center and added ten new galleries. The building itself has never changed uses but it is a successful adaptive reuse of a site and a reuse of spaces that change according to the art that is chosen for display.

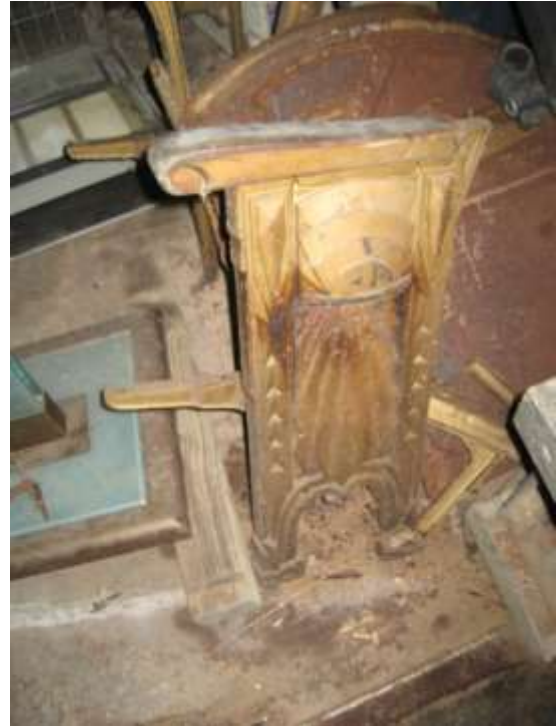
Figure 36: Original aisle panel for seating

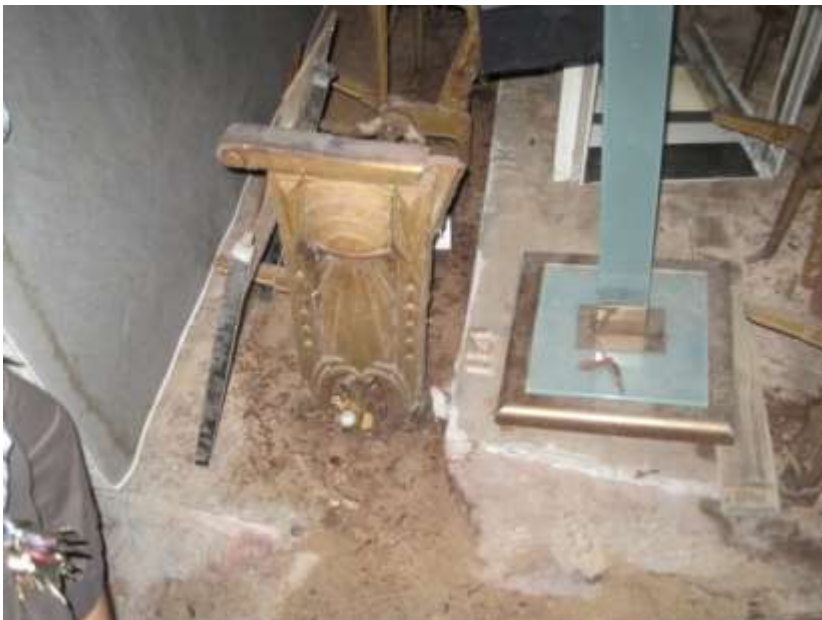
Figure 37: Original aisle panel for seating

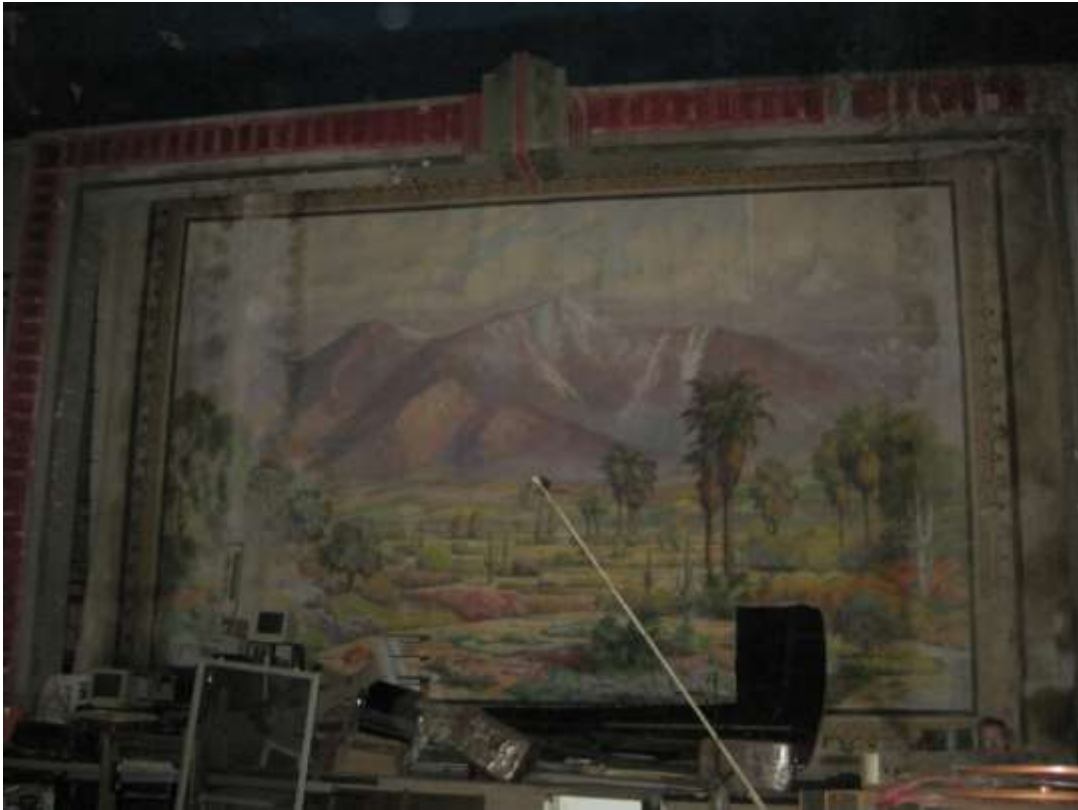
Figure 38: Full stage with curtain (contains Asbestos)

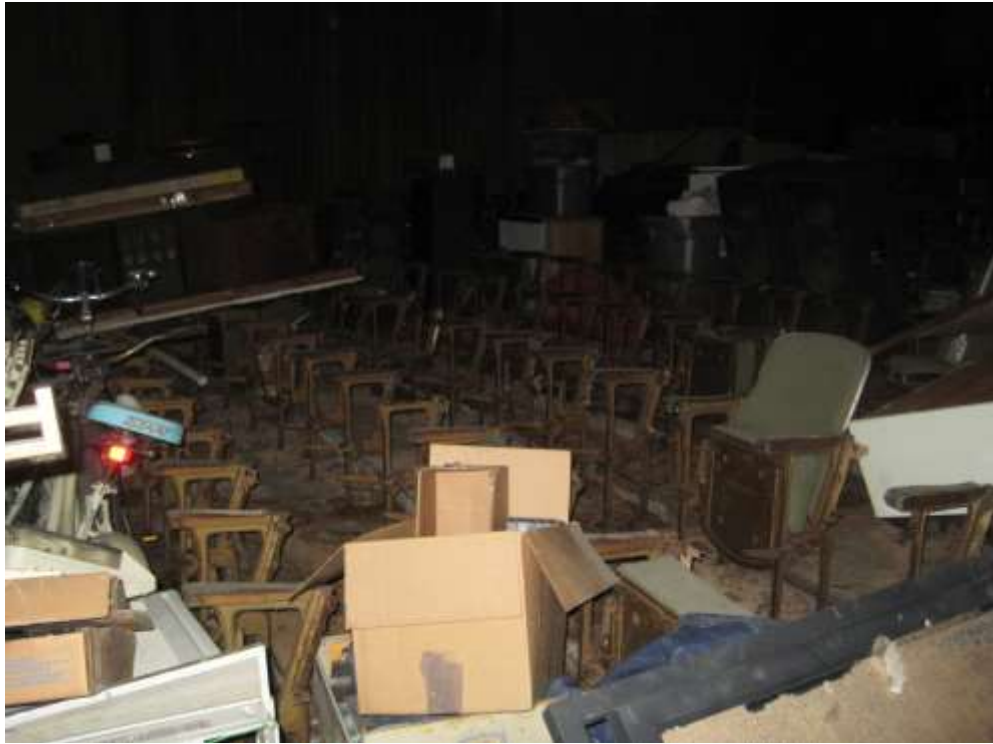
Figure 40: Seating frames, original.

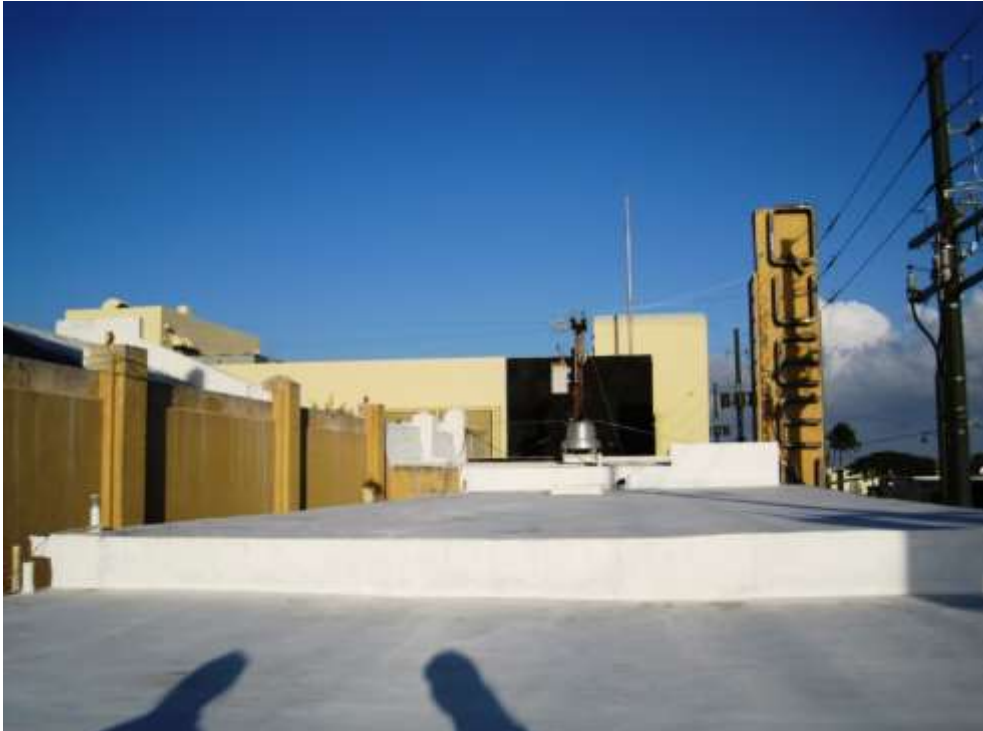
Figure 47: Roof of storefronts

The roof has some obvious leaks that will need to be repaired and investigated. Mike also mentioned that above the finished ceiling of the theater space there is about 16 feet of attic space. Apparently, they have been looking at what work needs to be done on the space to get the wiring up to code.

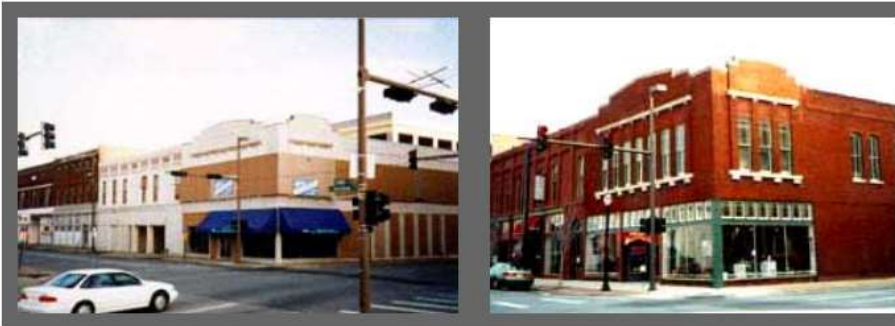
This two-story brick commercial building—with its corner storefront—was originally constructed ca. 1876, then remodeled in 1916 in the Craftsman style and given a new, distinctive roofline. It served a number of uses, including a hotel, boarding house, saloon, restaurant, liquor store, warehouse, and office furniture showroom. The red brick walls had been painted several times over the years. Rehabilitation work included removal of multiple paint layers using a chemical stripper and thorough water rinse; spot repointing with matching mortar; and appropriate interior alterations. The building is now being used as a retail shop. Photos: NPS files.
